ST MARY'S CHURCH - SPROTBOROUGH

STRUCTURAL REPAIRS TO ROOF

Submission for the King of Prussia's Gold Medal Award - 2010 - by Andrew Wiles

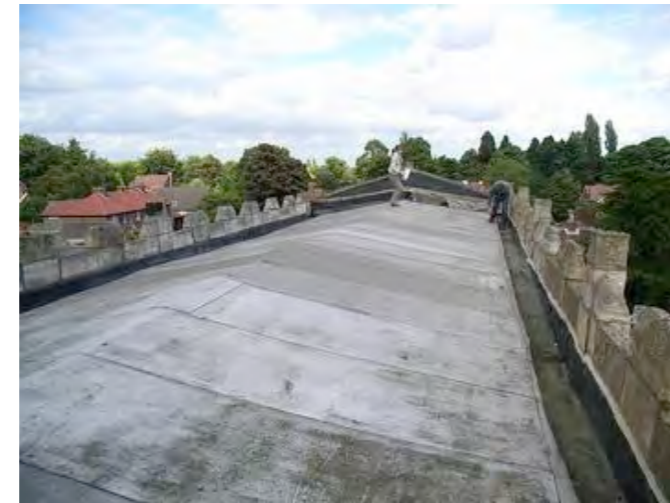
Existing asphalt roof coverings. The gutters were poured asphalt.

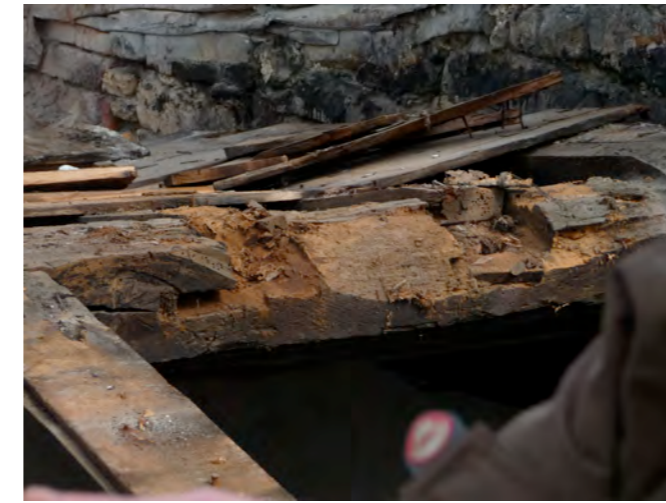
Decay of ridge member.

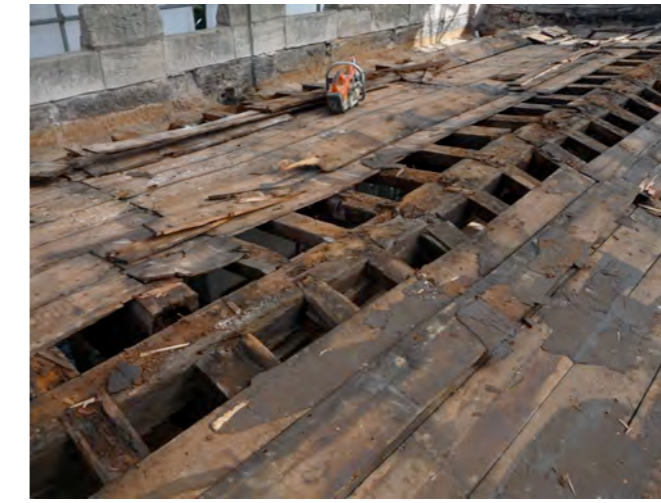
Ridge had snapped on the centre line.

Visiting the site we observed that, as the contractor had begun to remove the damaged honeycombed roof boards, the previously hidden upper faces of the tie beam trusses were honeycombed by death watch beetle. The decay was so advanced that the heartwood at the end of several tie beams could be excavated with ones fingers several inches past the bearing point on the masonry. The purlins and their joints seemed to be in fair order, but the heavily profiled ridge beam was exceptionally weak, particularly at its lapped connection to the truss, in one place it just snapped across its width.

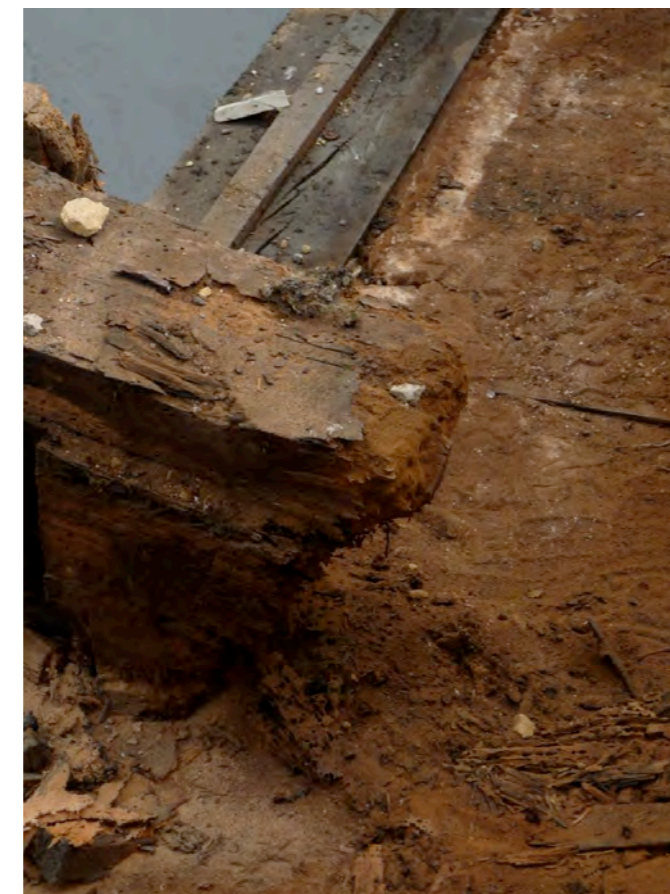
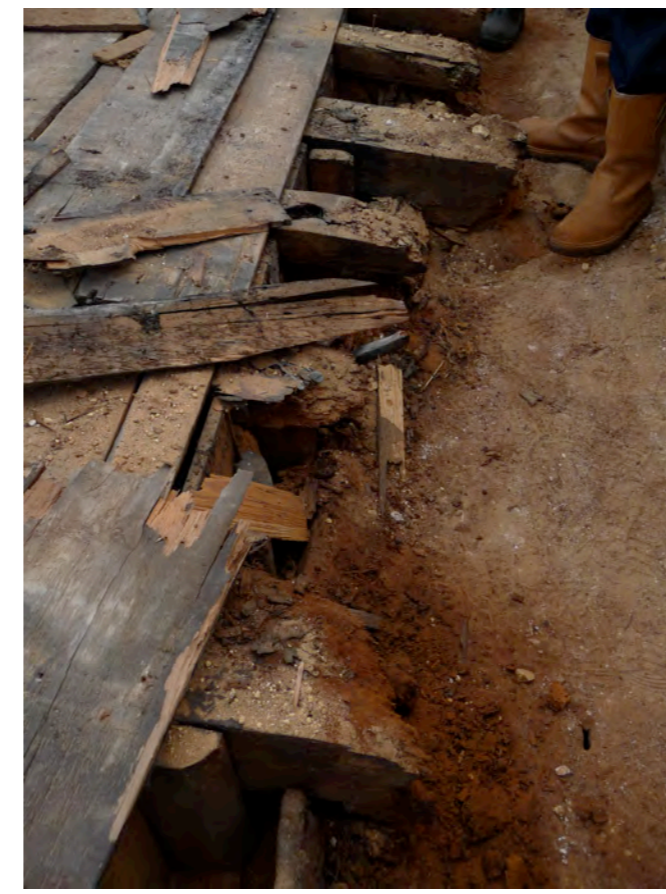
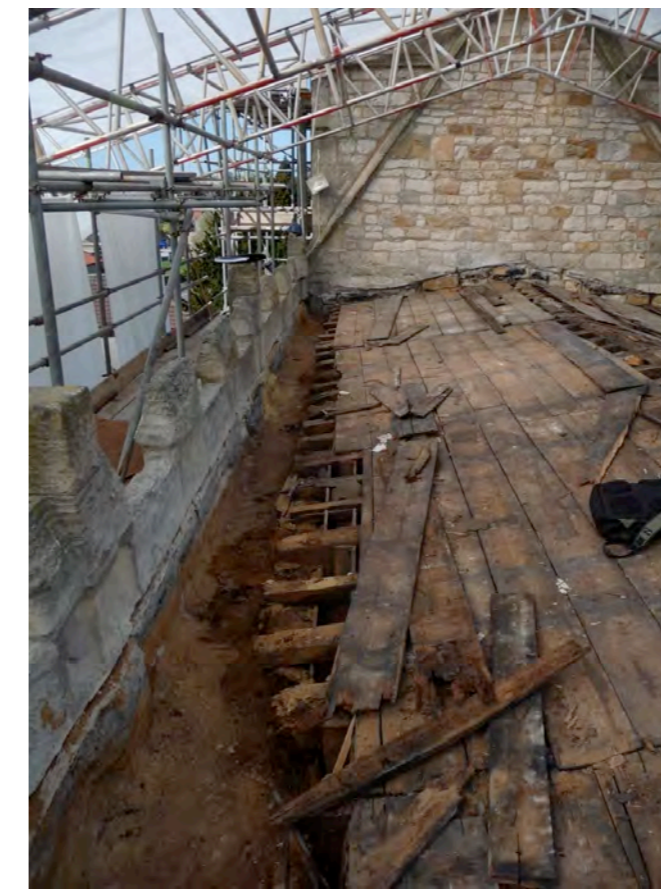
Typical condition of beam and rafter ends. The remains of the wall plate could be removed with a vacuum cleaner.

If this was not alarming enough, the condition of the timbers in the wall plate area was very difficult to believe. What was once a massive oak timber was so weakened by historic insect infestation that the contractor could remove the structure with a vacuum cleaner - there was nothing solid left.

It became clear to us that when the death watch beetle infestation had been tackled in the 1990s the contractor had faced up the historic wall plate with thin new timber to simply cover the weakened rafter ends. When we had investigated the roof from below prior to starting the works these facings (along with wide areas of the trusses) had firmly resisted a probe and seemed like the sound timber. - The real problems were hidden deep behind.

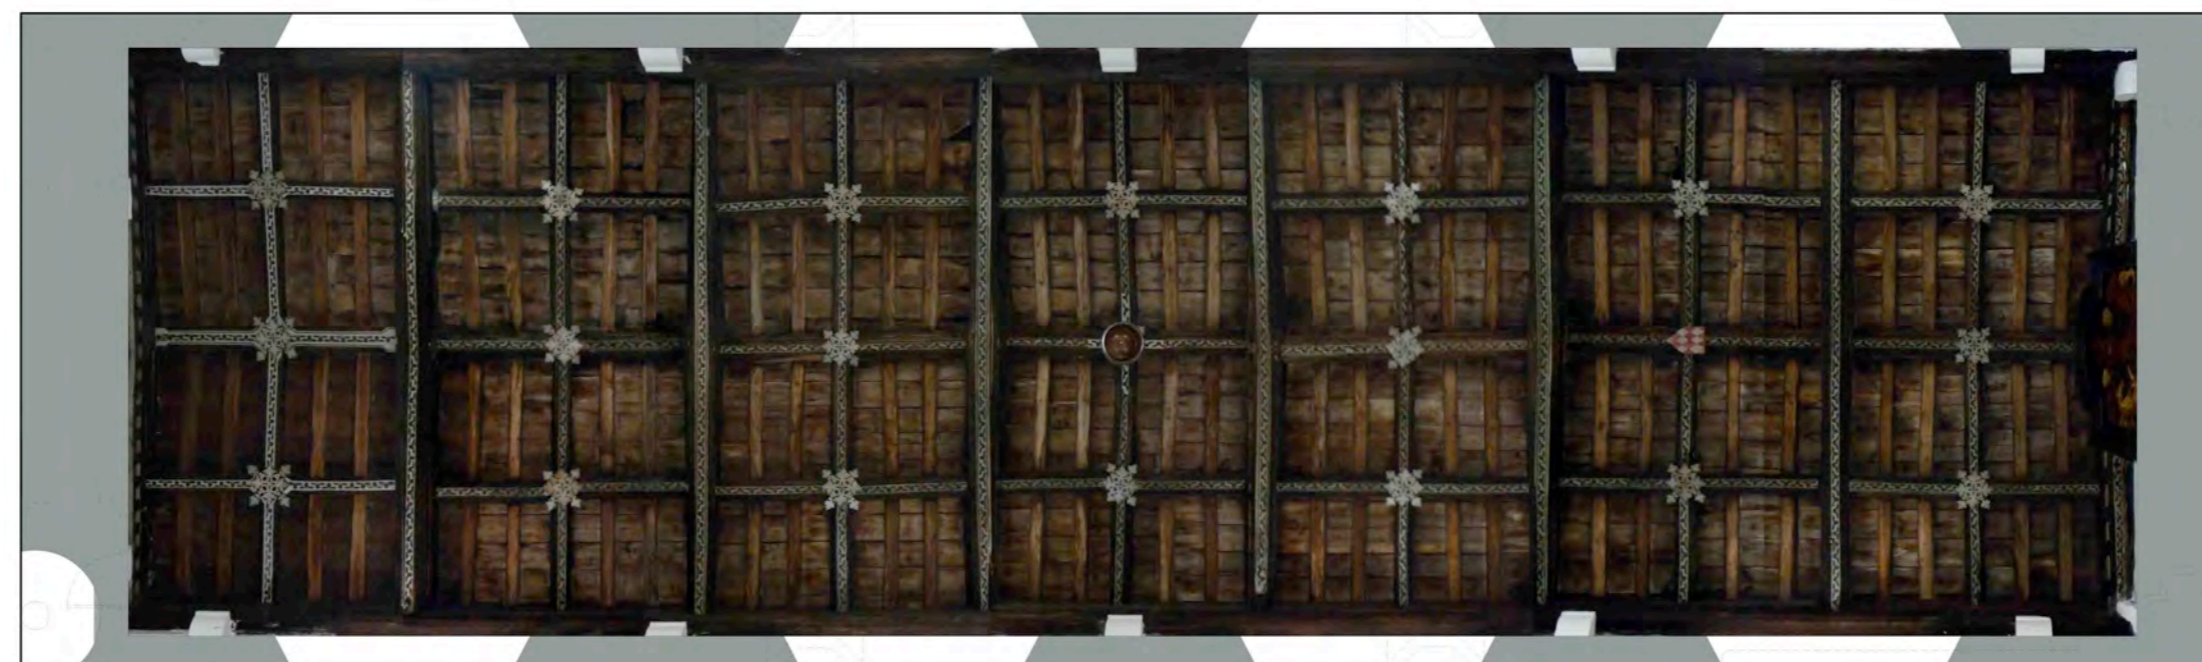
Survey photograph of roof structure prior to works

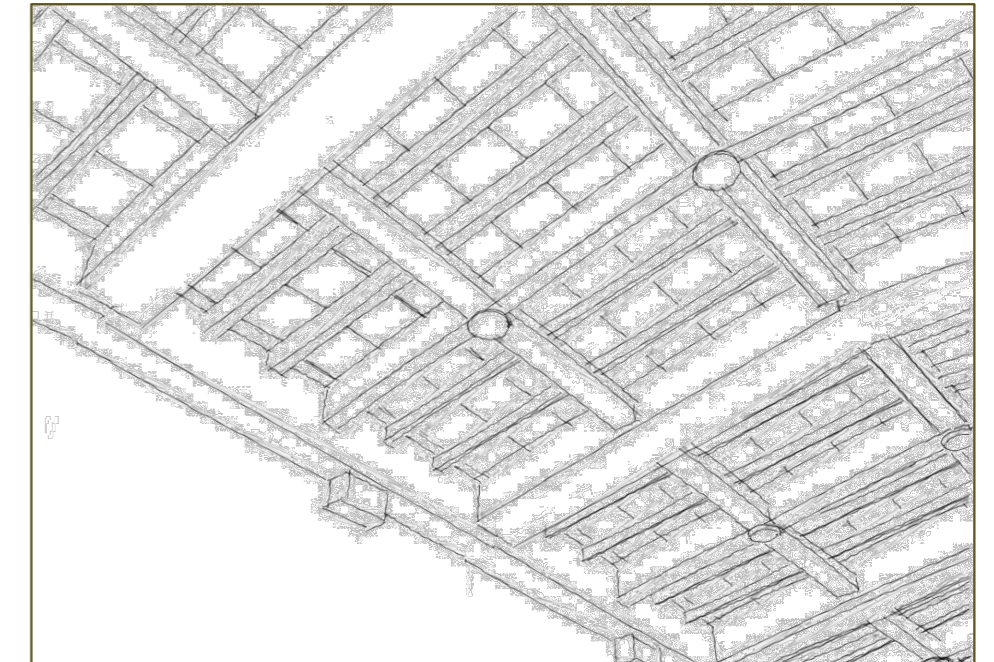
Survey sketch of roof prior to works

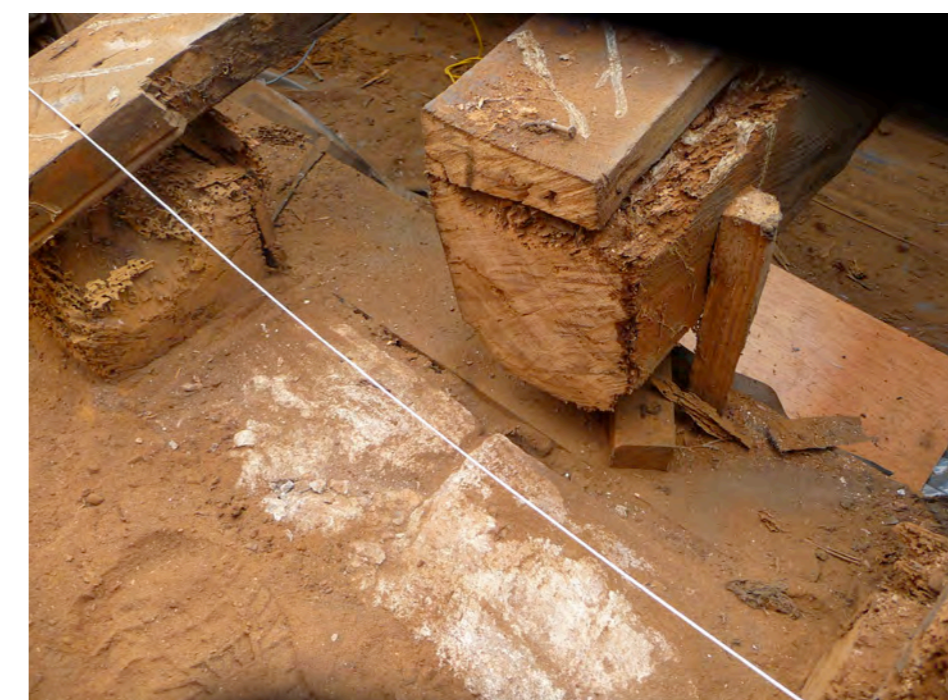
Photograph showing one rafter end following trimming of frass. It falls short of the bearing by 50mm.
