ST MARY'S CHURCH - SPROTBOROUGH

STRUCTURAL REPAIRS TO ROOF

Submission for the King of Prussia's Gold Medal Award - 2010 - by Andrew Wiles

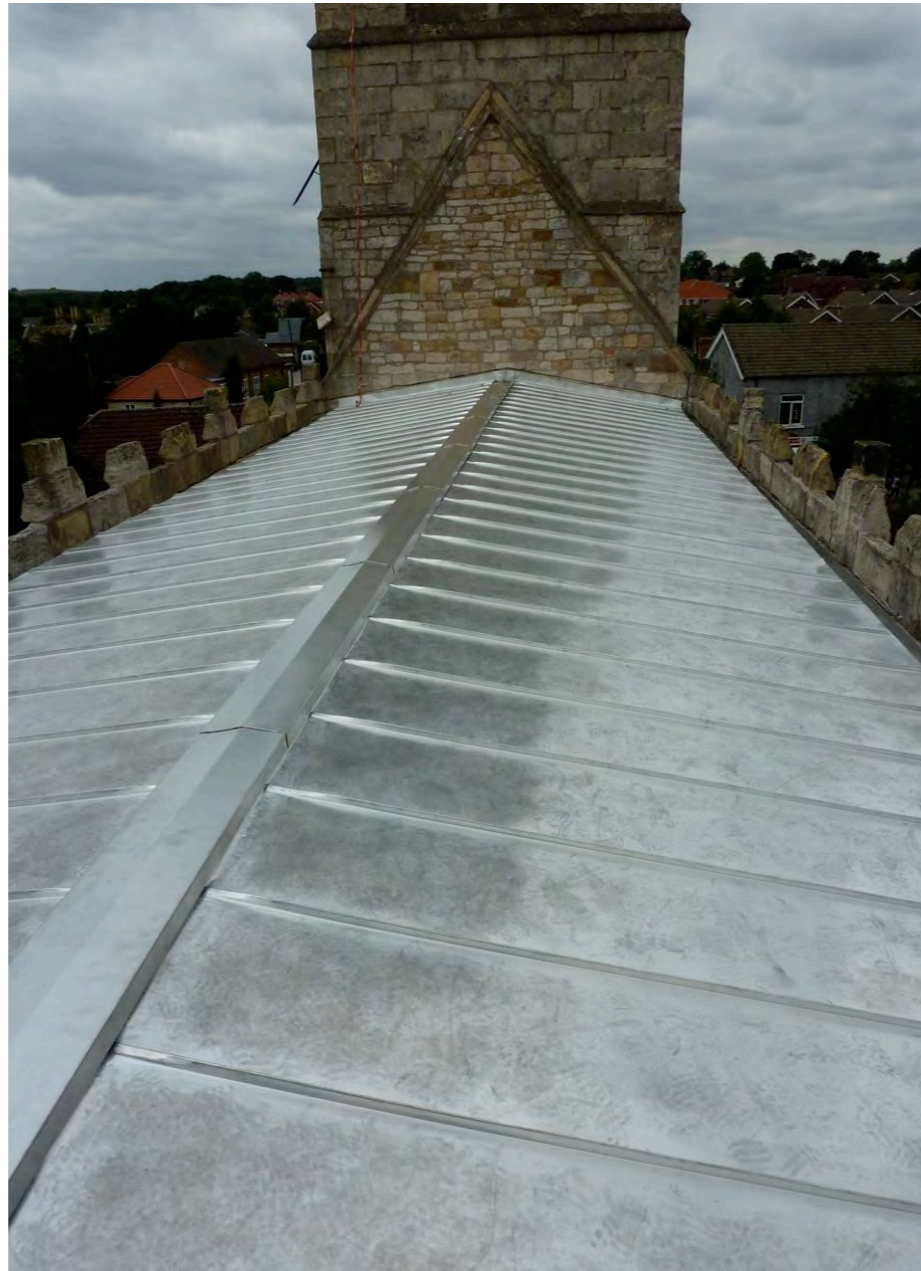
The complete roof.

The repair option we identified in the end was considered by English Heritage and the DAC to be simple, innovative and guaranteed the retention of the maximum amount of historic material. In consultation with a structural engineer (Brian Jones) we proposed to install on the line of each historic tie beam a low profile steel portal frame truss with purlins spanning between. These trusses rested on pads in the empty wall plate void and provided a 'strong back' to which the weak historic timbers could be suspended with secret fixings. The portal frame was manufactured to follow the pitch of the original roof boarding meaning the entire roof deck only needed to be raised 150mm above the original line.

The new steel structure also took the weight of the new plywood deck and insulation for the stainless steel roofing. The historic structural members and the joints needed only to support their own weight now, almost like a suspended ceiling grid. As they had no structural role we did not need to excavate the frass back to sound timber and the beam's shape, and the historic decorated finish was retained almost one hundred per cent. Sadly the original roof deck boards were weakened by insects beyond repair and new wide deal boards were secured in their place.

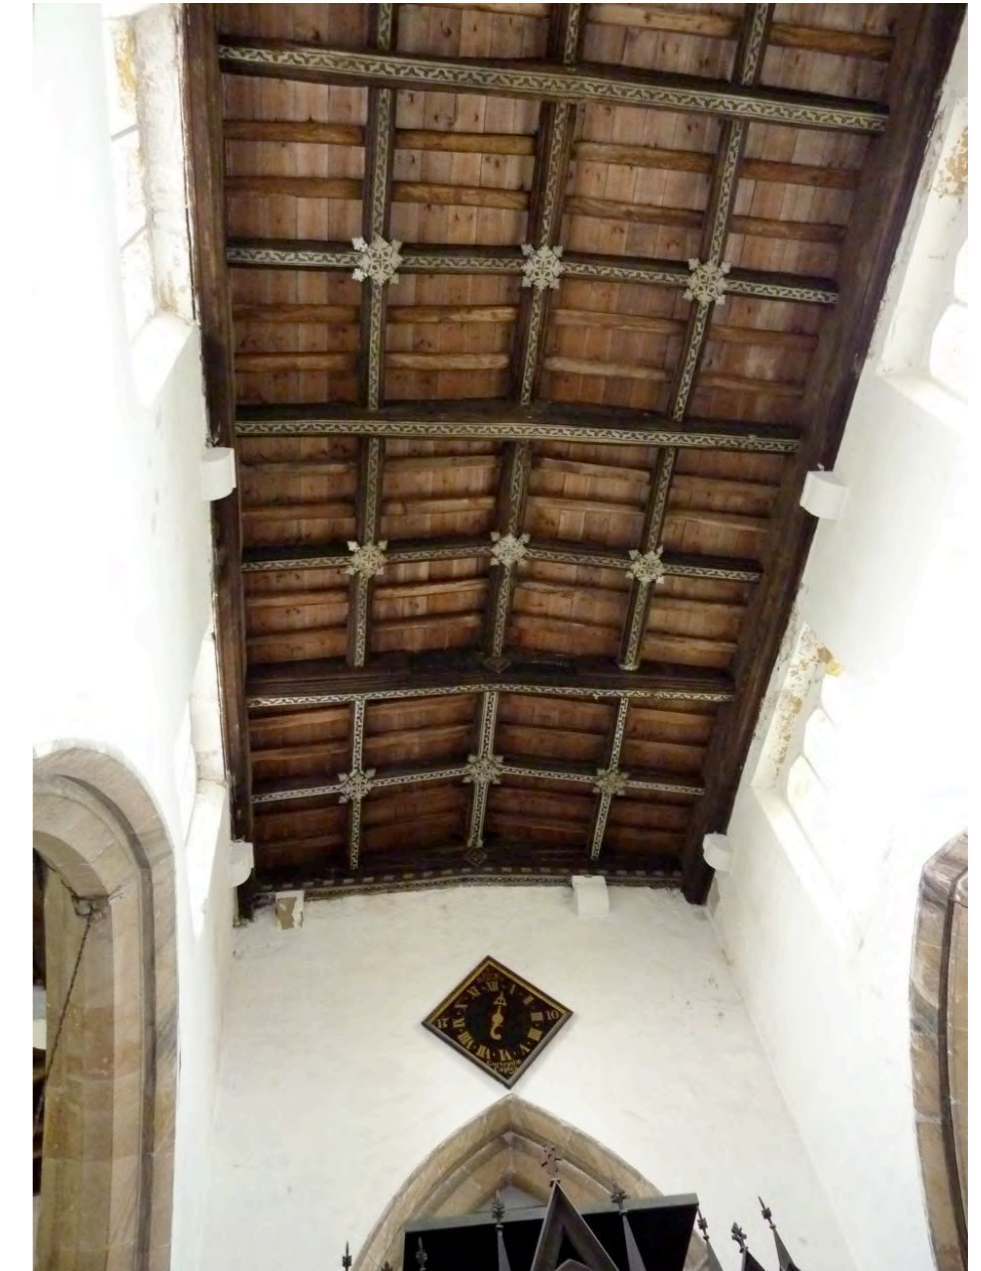
The completed roof from below.
